Report of  
Phase I Environmental Site Assessment

Class Termite and Pest Control, Inc.  
1640 Cabrillo Avenue  
Torrance, California 90501

June 30, 2008

Ellis Project 09-092

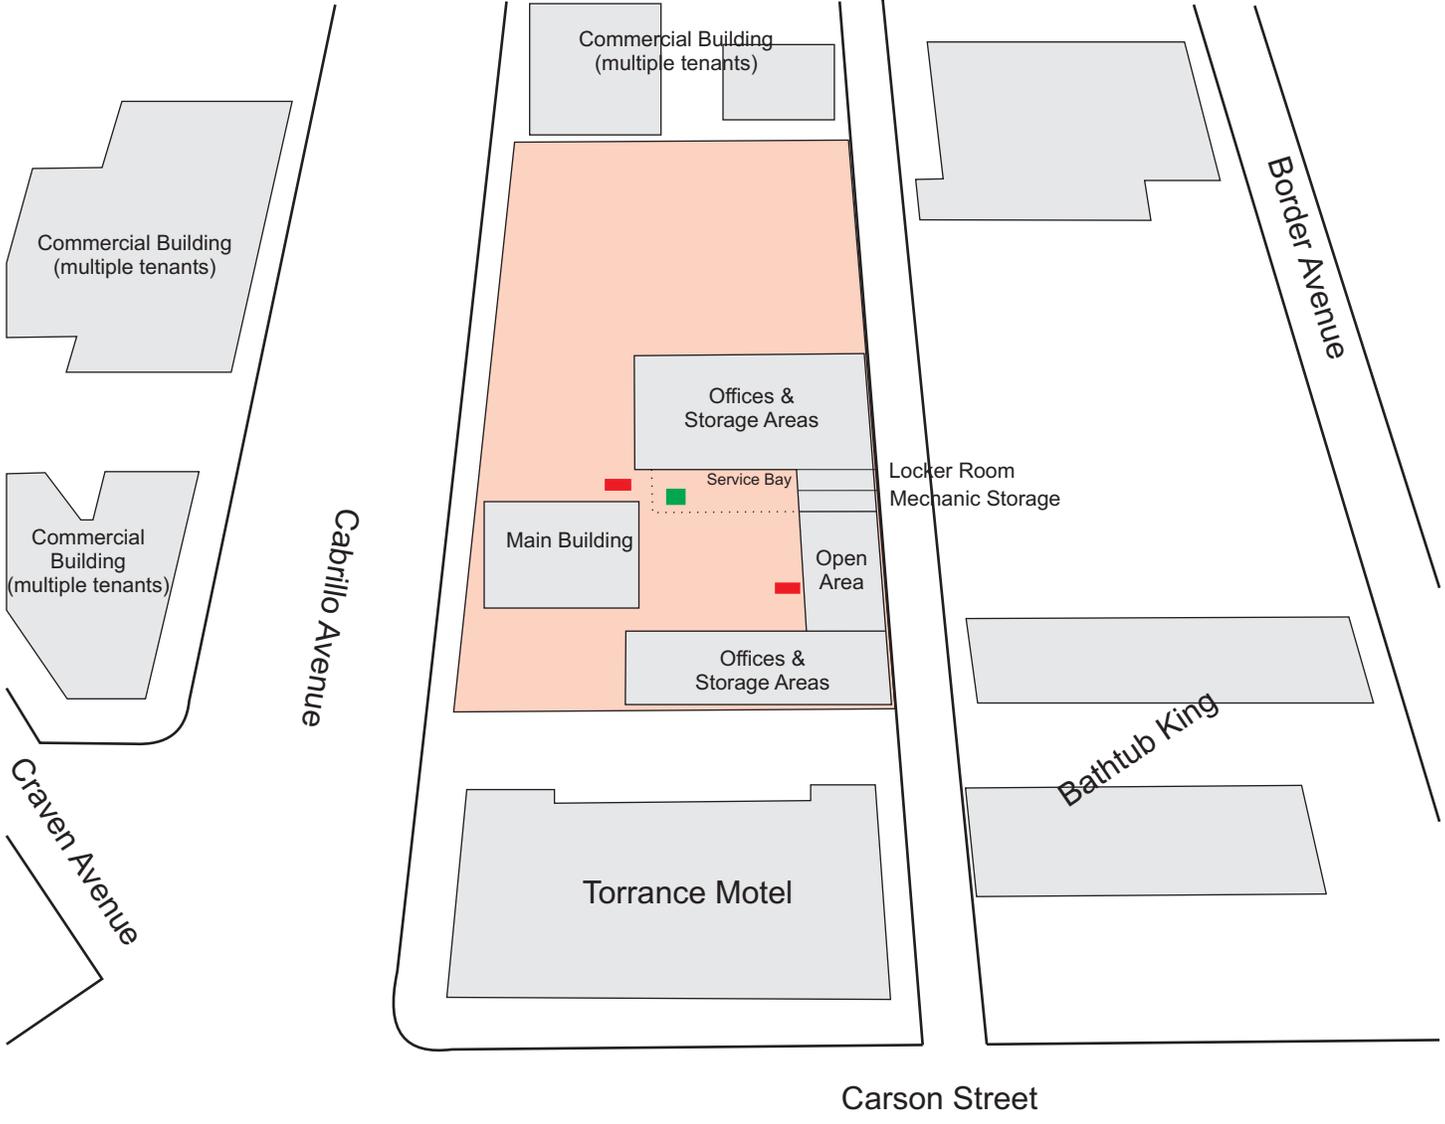
- Evidence of two abandoned underground storage tanks were observed on the subject property south of the service bay. Each tank has a filling neck with

- One inactive hydraulic lift was observed in the service bay of the subject property. The underground lift has likely been located at the subject property since its construction in the 1950's. The hydraulic lift has not been used in over 30 years since the current occupant occupied the subject property. The production of polychlorinated biphenyls (PCBs), chemicals formerly used in hydraulic fluid, was banned in the United States by the United States Environmental Protection Agency (USEPA) in the late 1970's. Based on the time period the subject property was occupied as a car dealership (1950's – 1970's), there was a potential that the underground hydraulic lift may be PCB containing. The underground hydraulic lift is therefore considered to be a recognized environmental condition in connection with the subject property.

- Underground/Above Ground Storage Tanks
- Hydraulic Lift

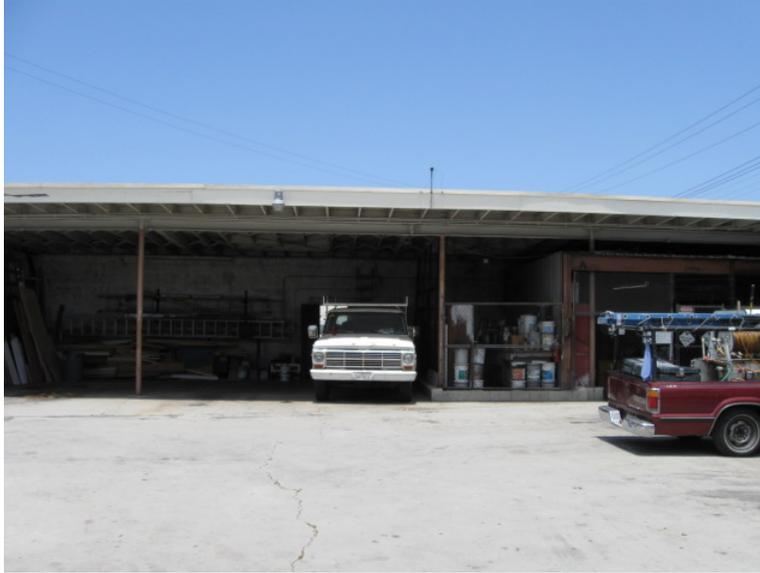
Pesticide related products were observed at the subject property. These items were properly labeled and stored with no apparent leaking, odors, or corrosion noted. Based on the observed storage practices, these substances do not appear to be evidence of a recognized environmental condition in connection with the subject property.

Photo 7 View of subject property - chemical storage area

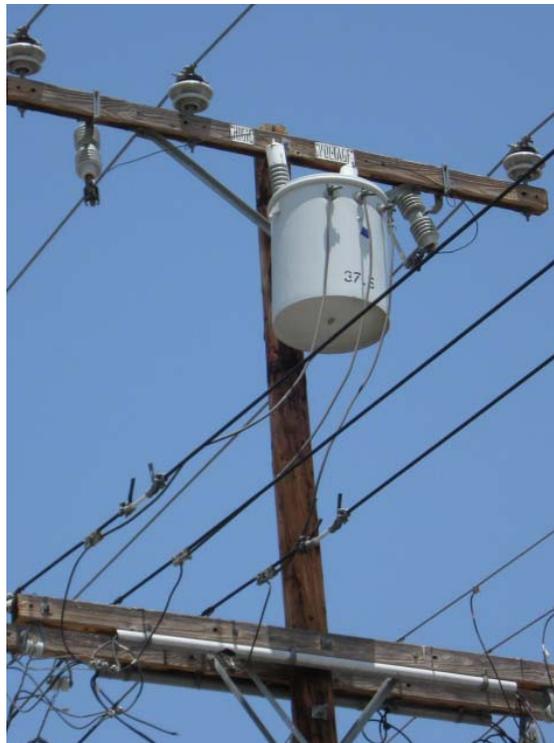
One pole-mounted transformer was observed along the east side of the subject property, which appeared in good condition. This transformer is the property of Southern California Edison, who assumes responsibility for any cleanup associated with

their equipment. This transformer does not represent a recognized environmental condition in connection with the subject property.

Photo 10 View of pole-mounted transformer located on subject property

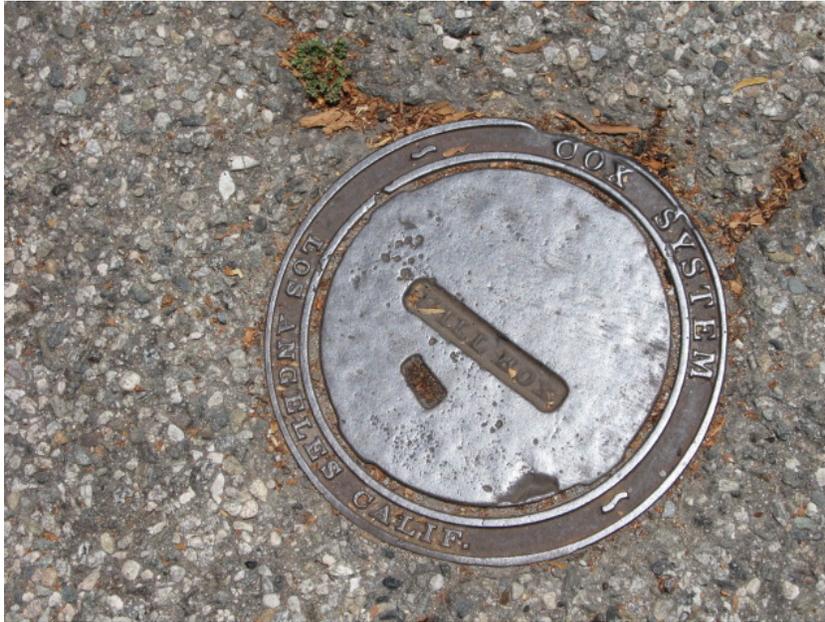
Evidence of two abandoned underground storage tanks were observed on the subject property located south of the service bay. Each tank has a filling neck with locked cap. The City of Torrance Fire Department or the Regional Water Quality Control Board have no records of UST's at the subject property.

Abandoned underground storage tanks are a potential source of contamination of the soil and ground water and may pose a fire and explosion hazard under certain conditions. These underground storage tanks are therefore considered to be a recognized environmental condition in connection with the subject property.

Photo 11 View of fill box locked cap for UST located on subject property

Ellis recommends a Phase II Environmental Site assessment to determine whether the RECs identified above have resulted in a release of hazardous substances and/or petroleum products onto the subject property.
