February 17, 2022

**RE: *Bulk Sampling for Asbestos and Lead
Fire Station #4
5202 Calle Mayor, Torrance, CA 90505***

Proj. No.: 22-052

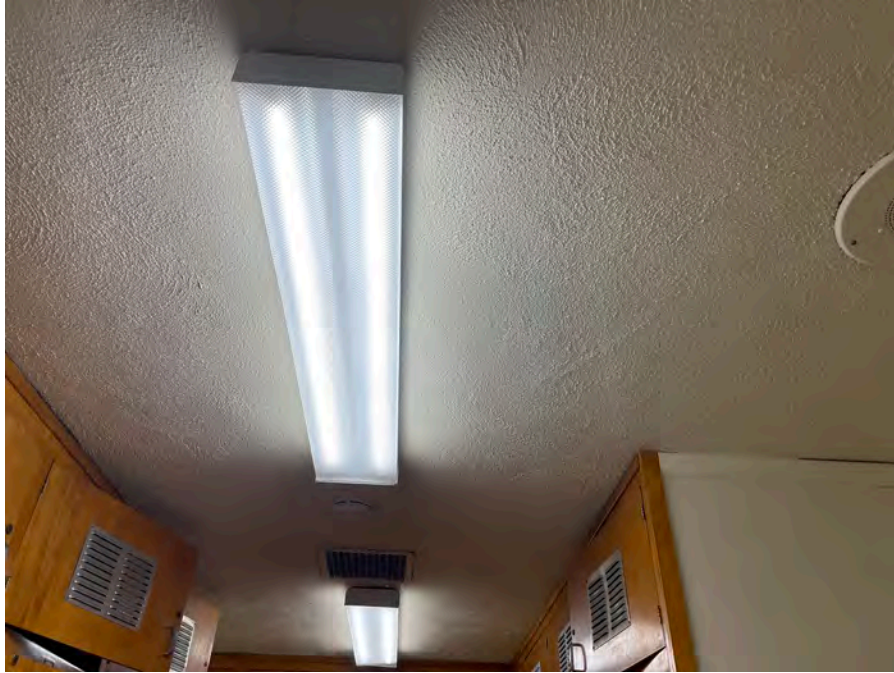
Non-asbestos textured ceiling plaster in hallway area.

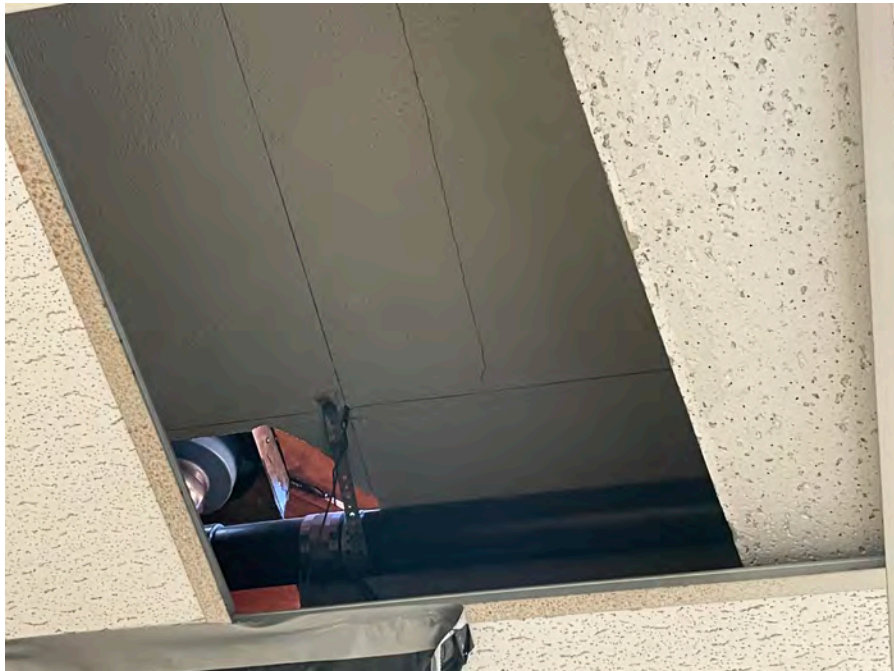
Non-asbestos textured ceiling plaster in subceiling space – dorm.

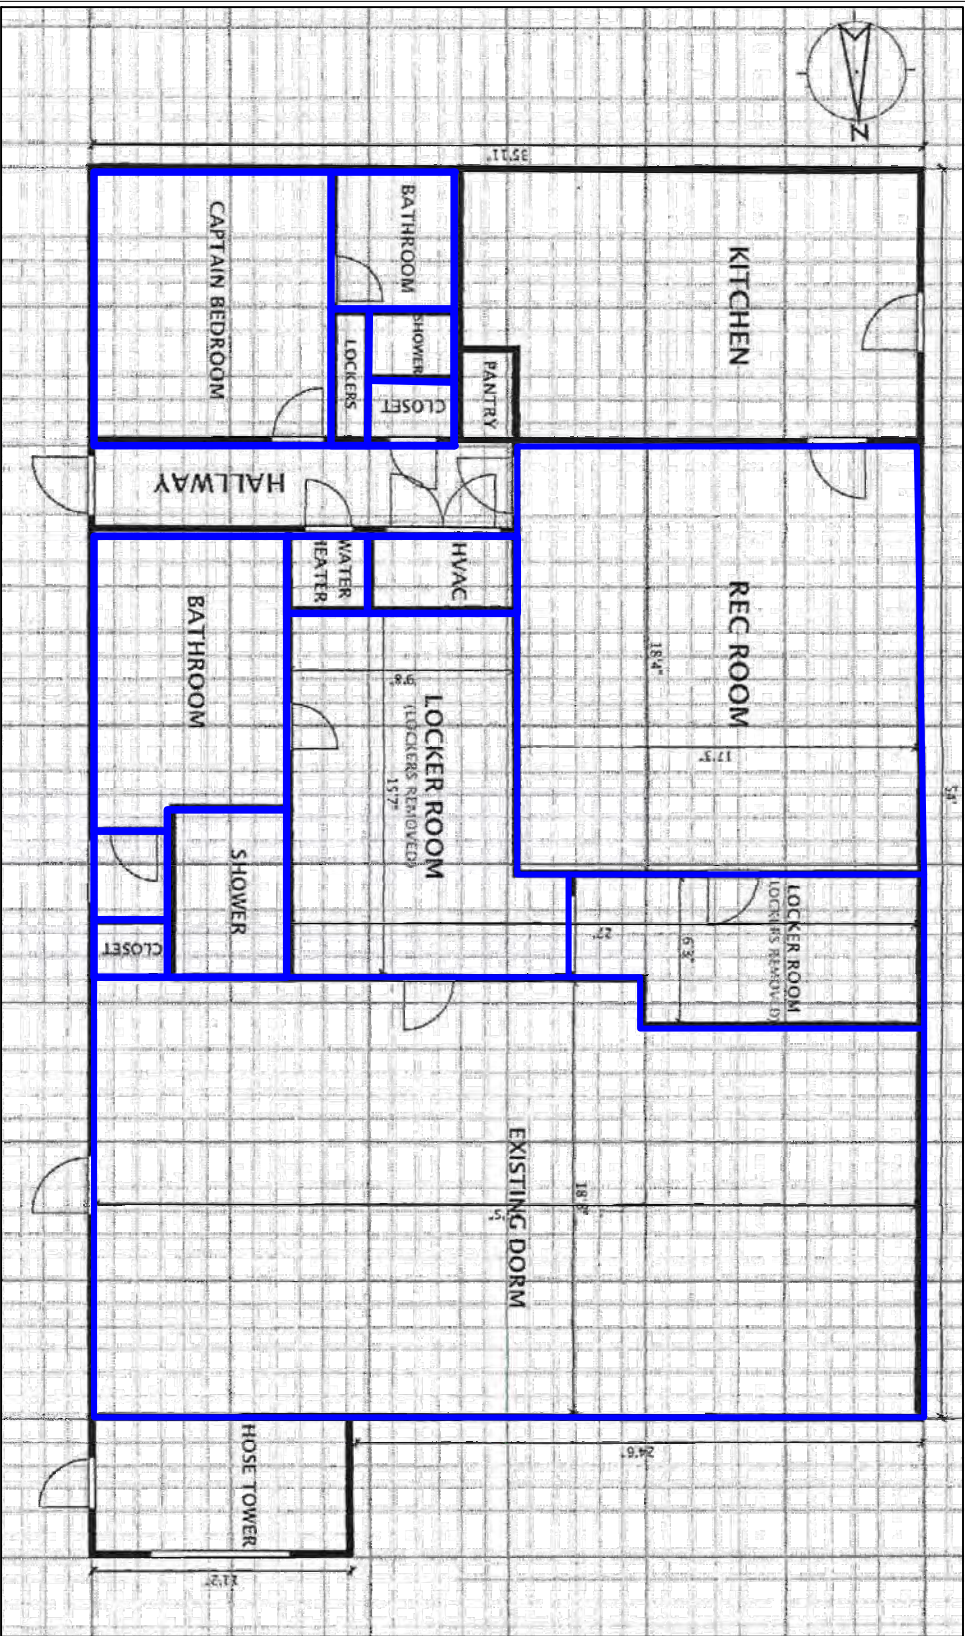
Figure 1: Material Locations
 Torrance Fire Station #4
 5205 Calle Mayor
 Torrance, CA 90505

1. White wall paint in the dorm, wellness area, recreational area, and weight room – (Ellis 17-430, 19-099)
(0.060 - 0.075% lead by wt., good condition)*

Blue lines indicate lead-based interior wall paint.
 (All areas excluding kitchen.)

Retain a licensed abatement contractor for the disturbance of the lead-based paint noted above. Drum and profile all uniquely generated waste streams prior to transportation or disposal. Avoid torching, welding, or mechanical abrading on lead-containing paints without prior exposure monitoring as is stipulated in Cal/OSHA Title 8 § 1532.1 – reference the attached lead “Trigger Tasks” document and regulatory summaries. See Table 2 for complete list of sampled materials.

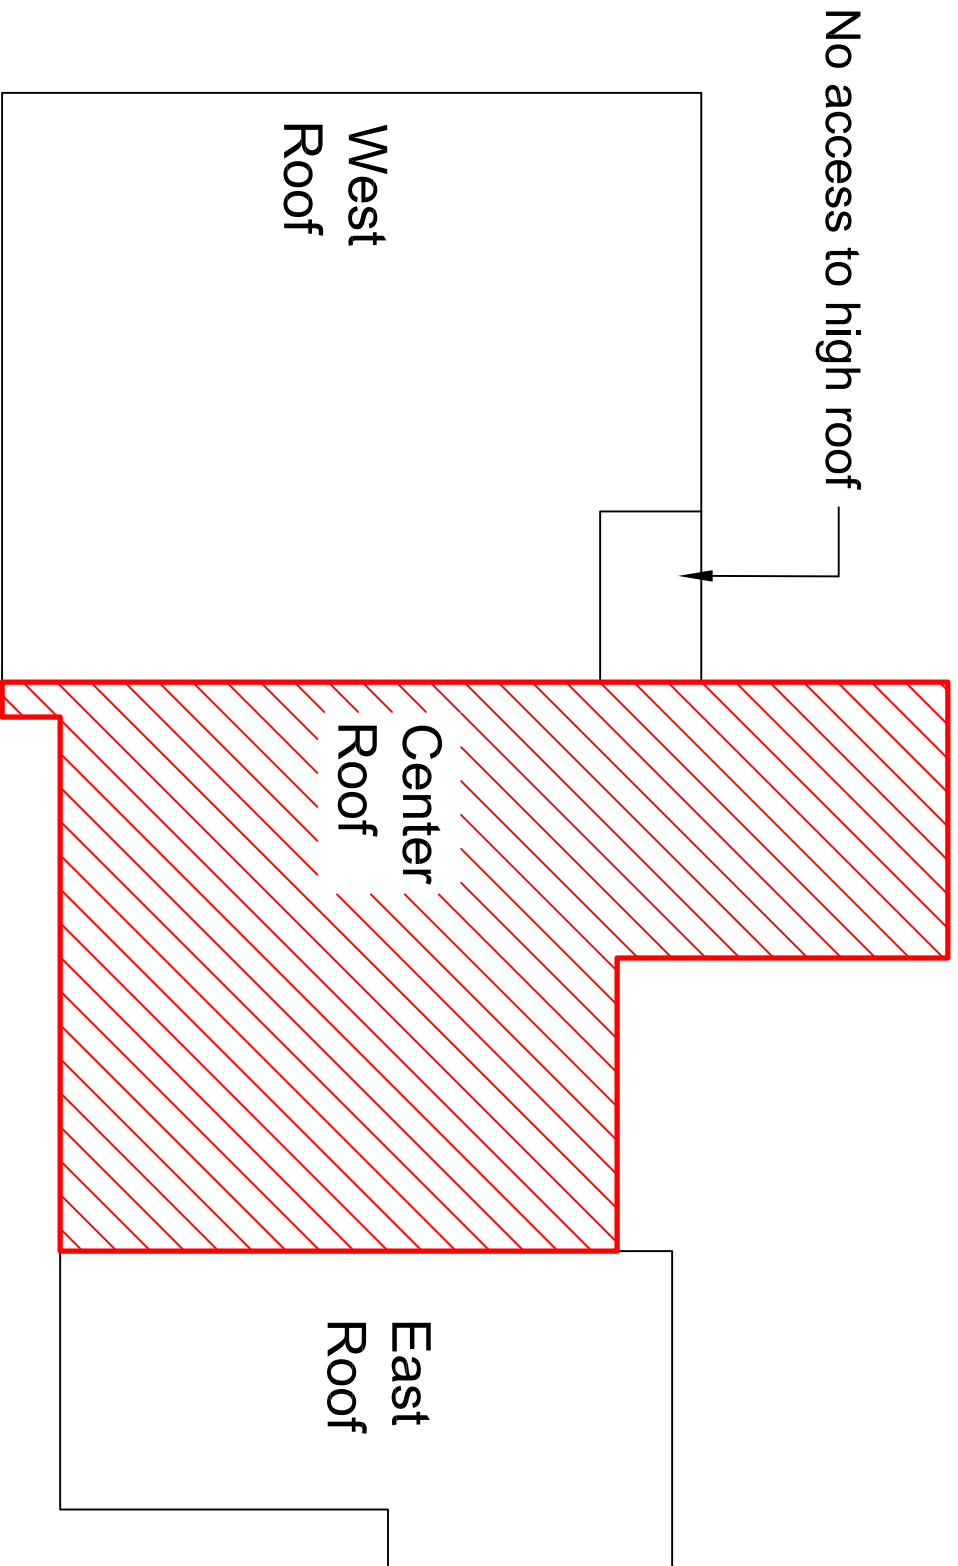
Figure 1: Material Locations
City of Torrance - Fire Station #4
5205 Calle Mayor
Torrance, CA 90505

1. Flashing mastic and pedestal mastic on the center roof (Ellis 21-063)
(*2% chrysotile; good condition / “non-friable” – 90 sq. ft. in quantity**)
2. Thermal System Insulation (TSI) throughout inner wall spaces (assumed)
(*Quantity and condition currently unknown*)
3. Mirror mastic (assumed)
(*Quantity and condition currently unknown*)
4. Asbestos-cement pipe (assumed)
(*Quantity and condition currently unknown*)

* Red lines and hatch notes asbestos flashing mastic and pedestal mastic located on center roof.

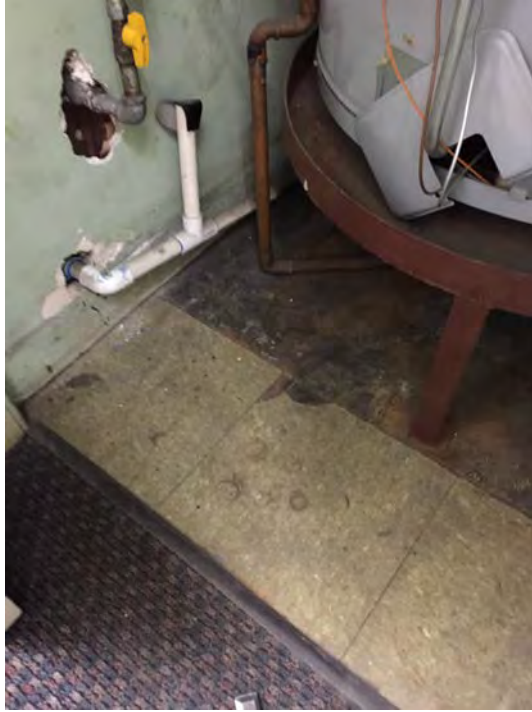
Brown 12" tile and mastic – 5% asbestos

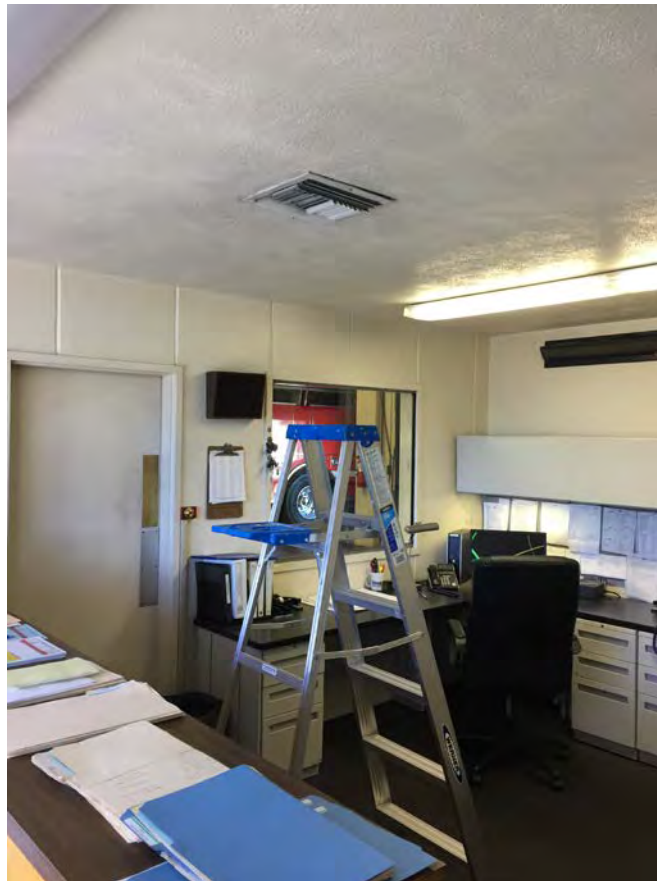
White ceiling paint (lead containing) and beige wall paint (lead based).

Lead containing white ceiling paint and
Lead based beige wall paint throughout.

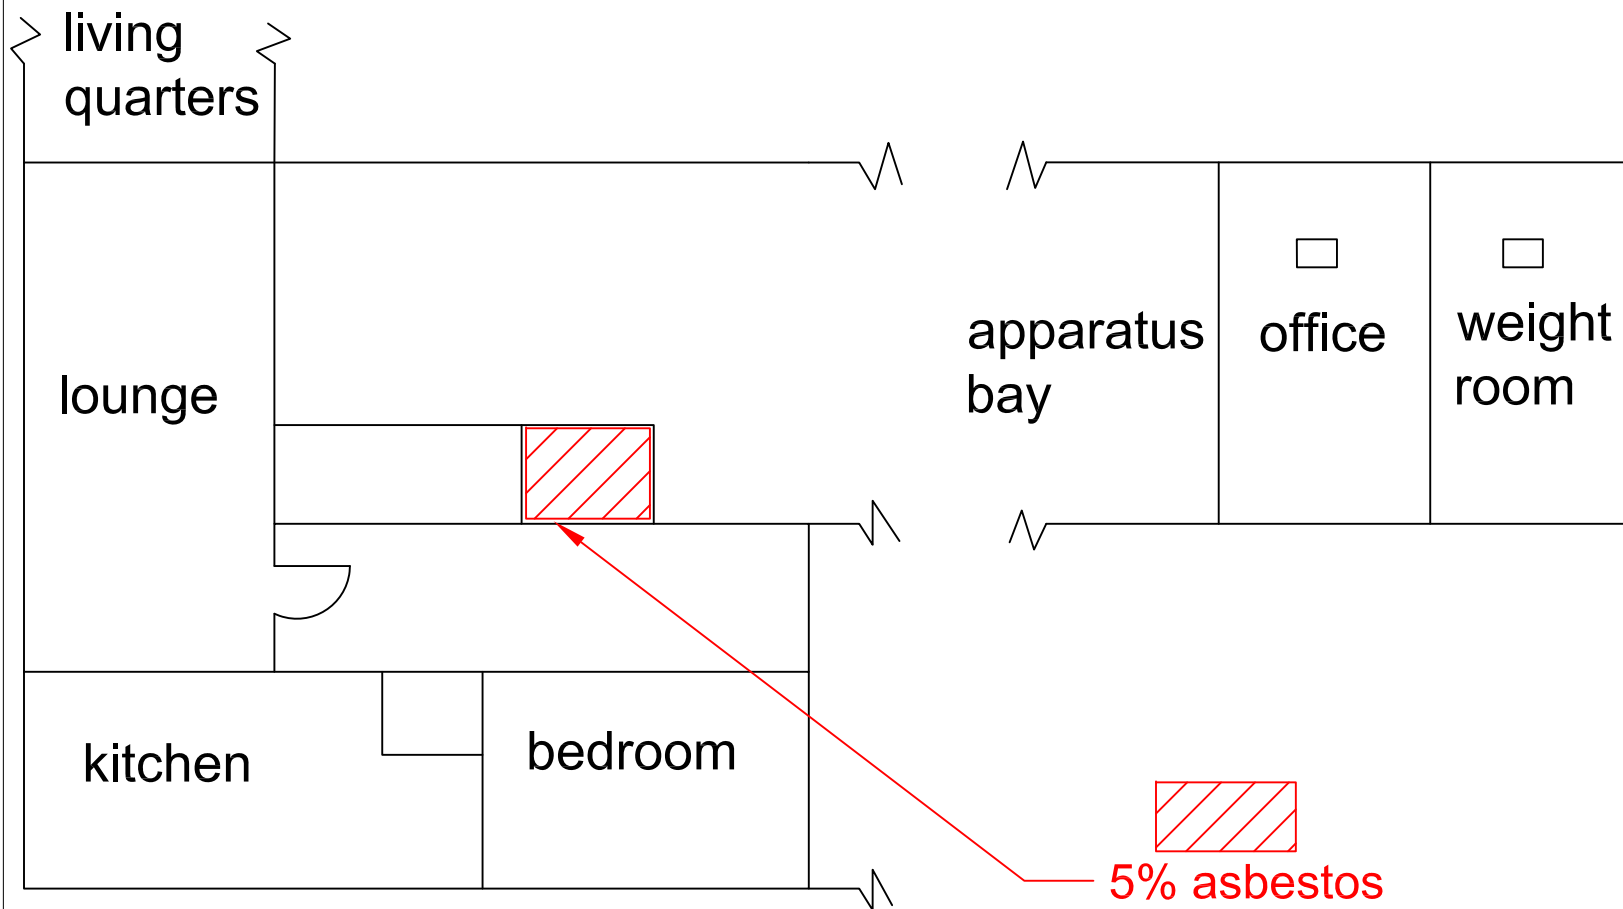
5% asbestos
12" Brown FT/ Mastic

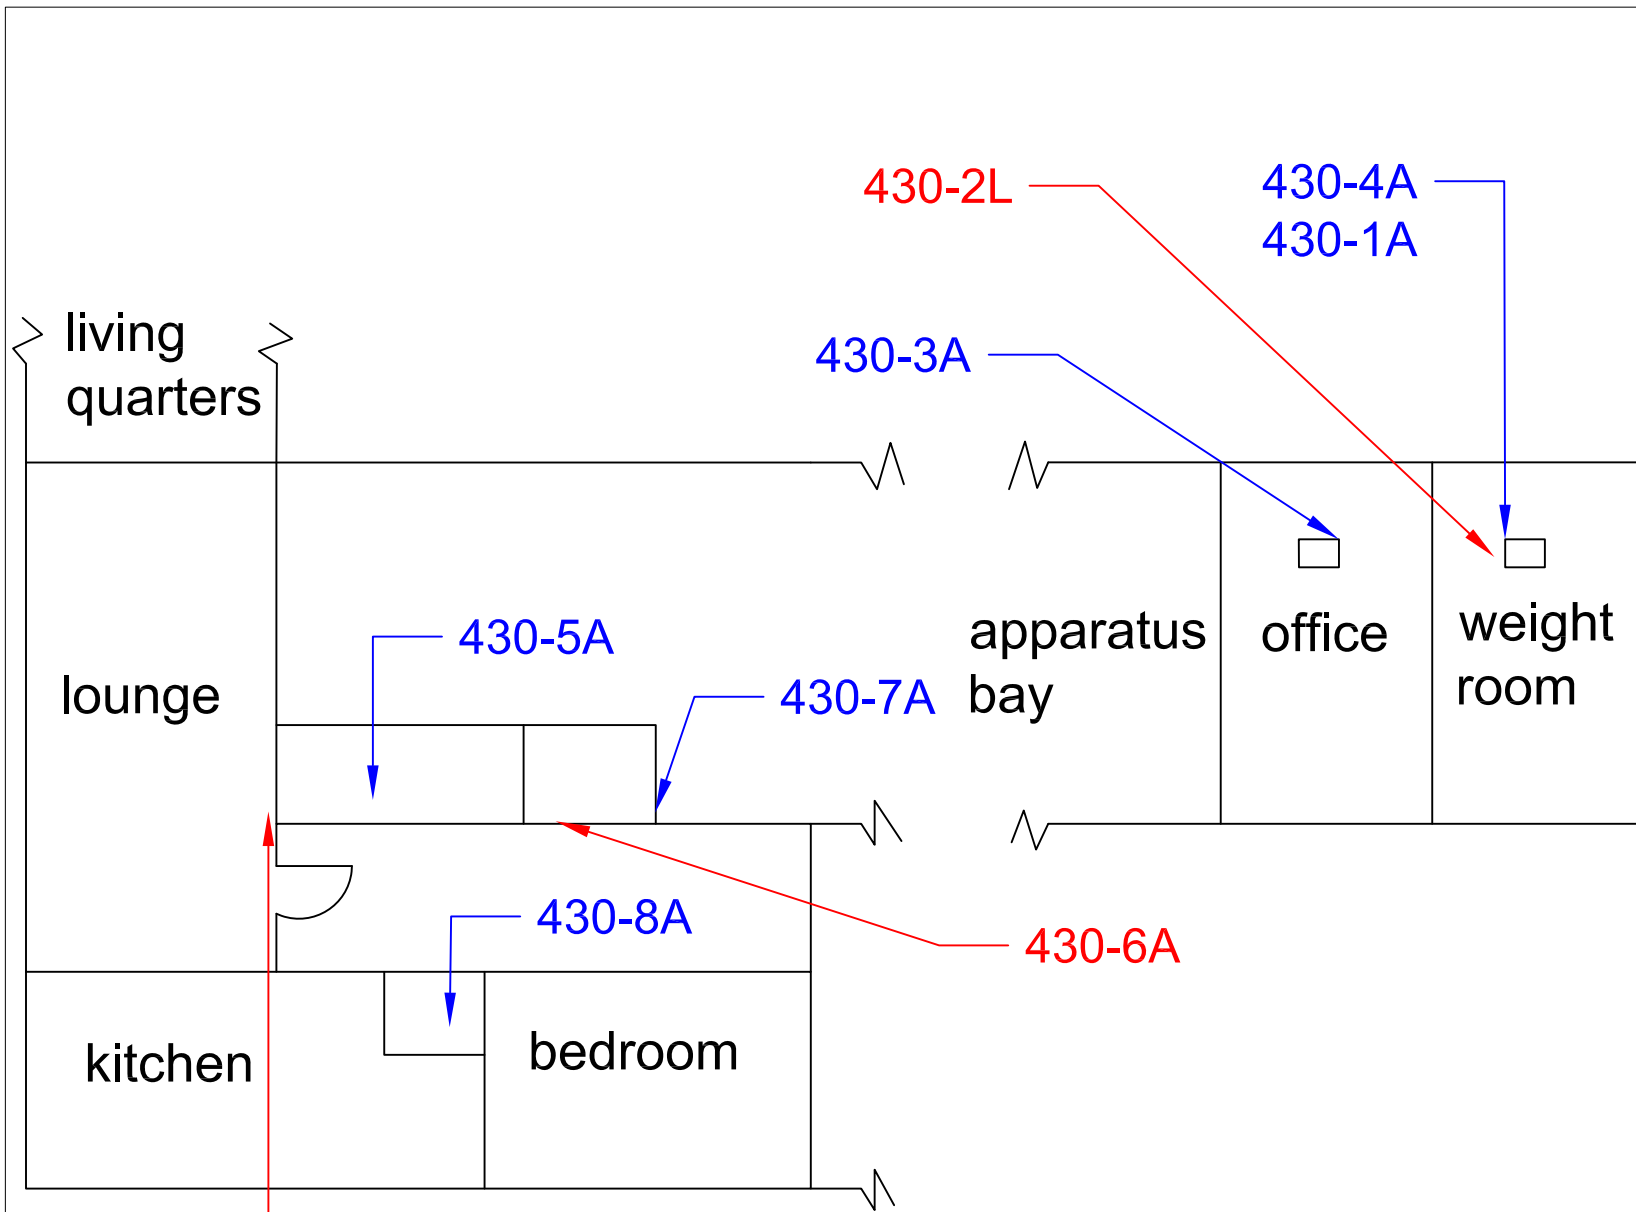
Red sample locations indicate asbestos or lead containing paint or lead based paint.

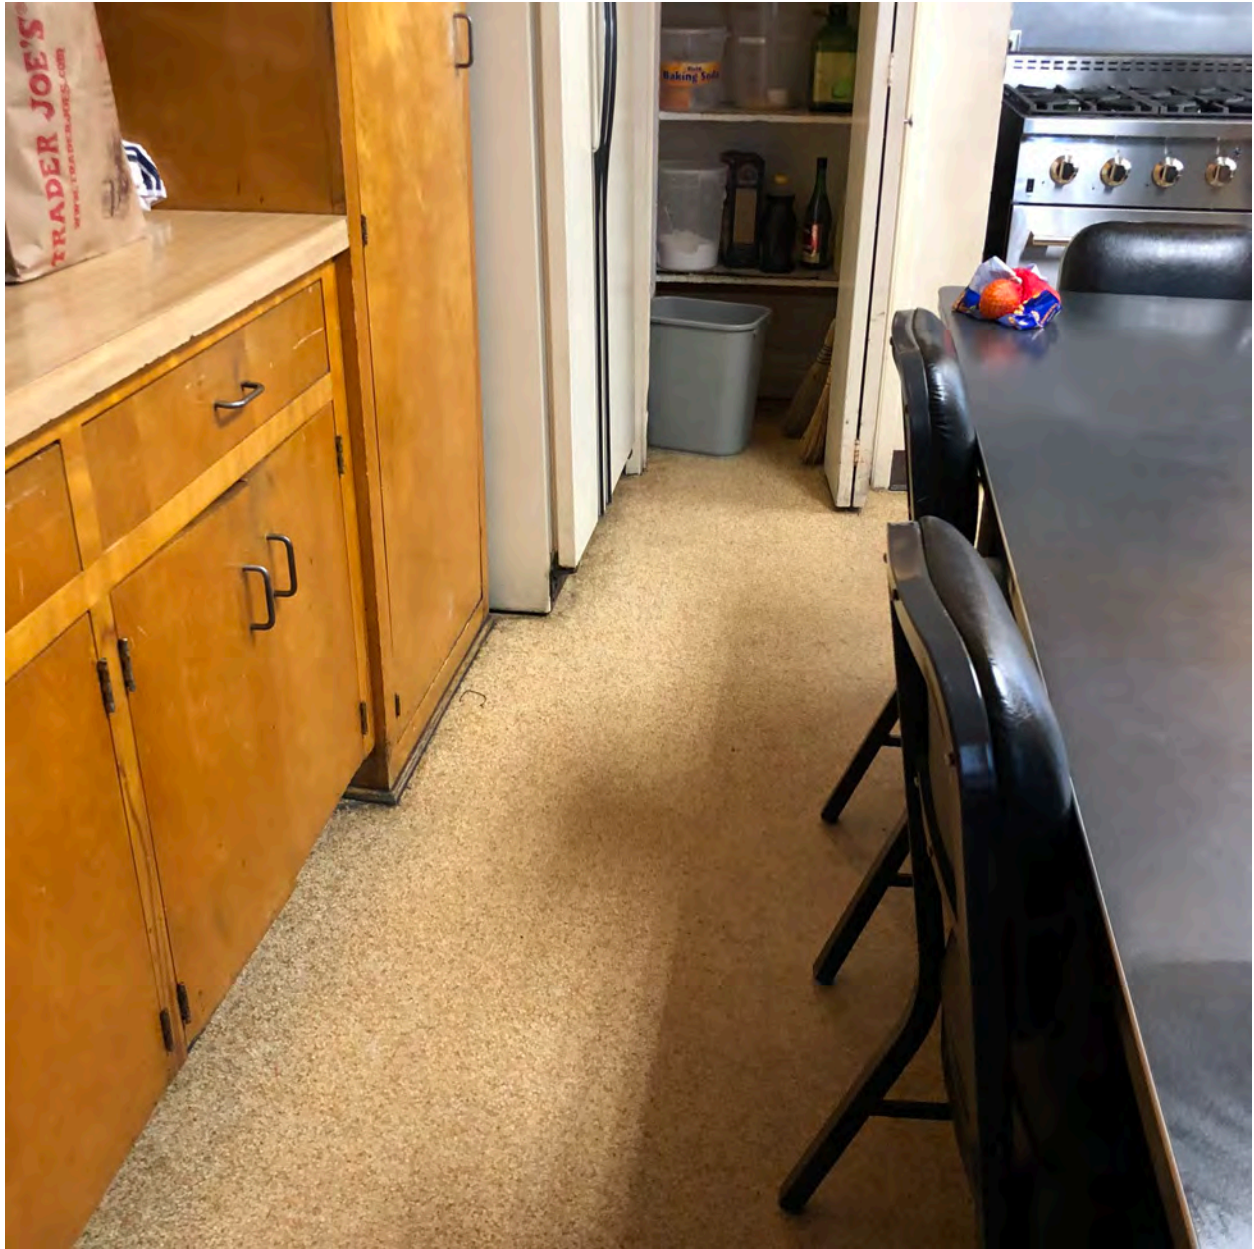
- **Asbestos (2% Chrysotile) was detected in mastic under sheet flooring in the kitchen.** Good condition. Non-friable. Approx. 230 s.f.
- **No asbestos was detected in** plaster walls, carpet glue and ceiling tiles. See Table 1 for a complete list of sampled materials.
- **Lead-based paint (0.075% by wt.) was found on dorm and recreational area walls.** Samples of white wall paint in the kitchen were non-lead containing.

Asbestos containing floor mastic and sheet flooring in the kitchen.

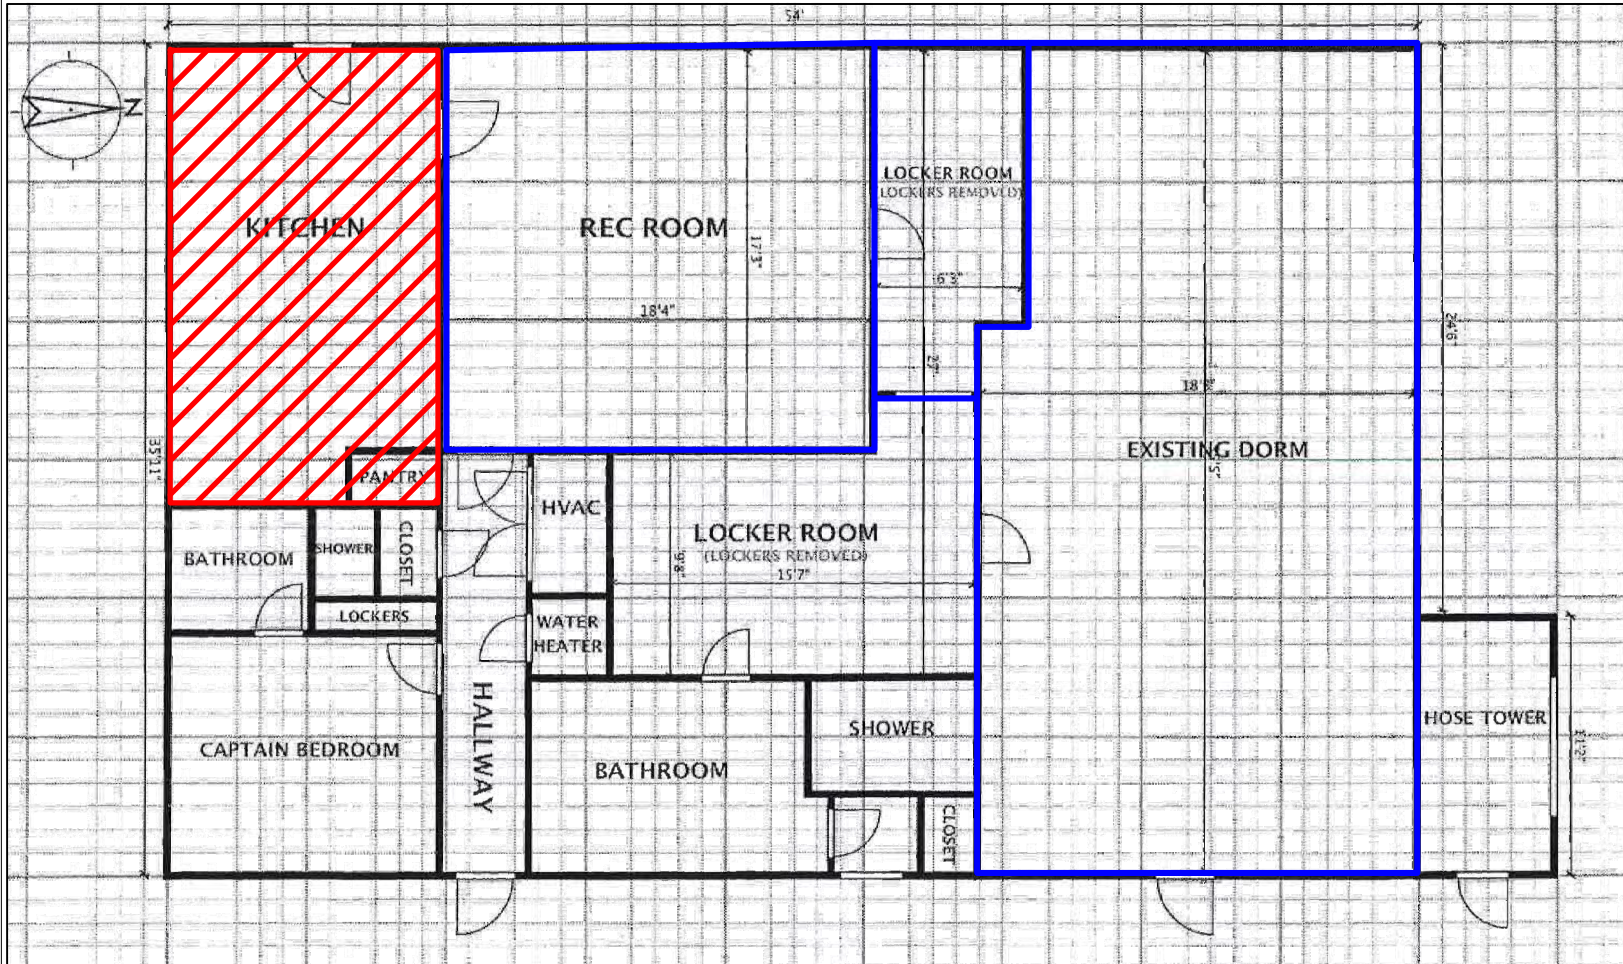
Figure 1: Material Locations

Blue lines show lead-based wall paint.

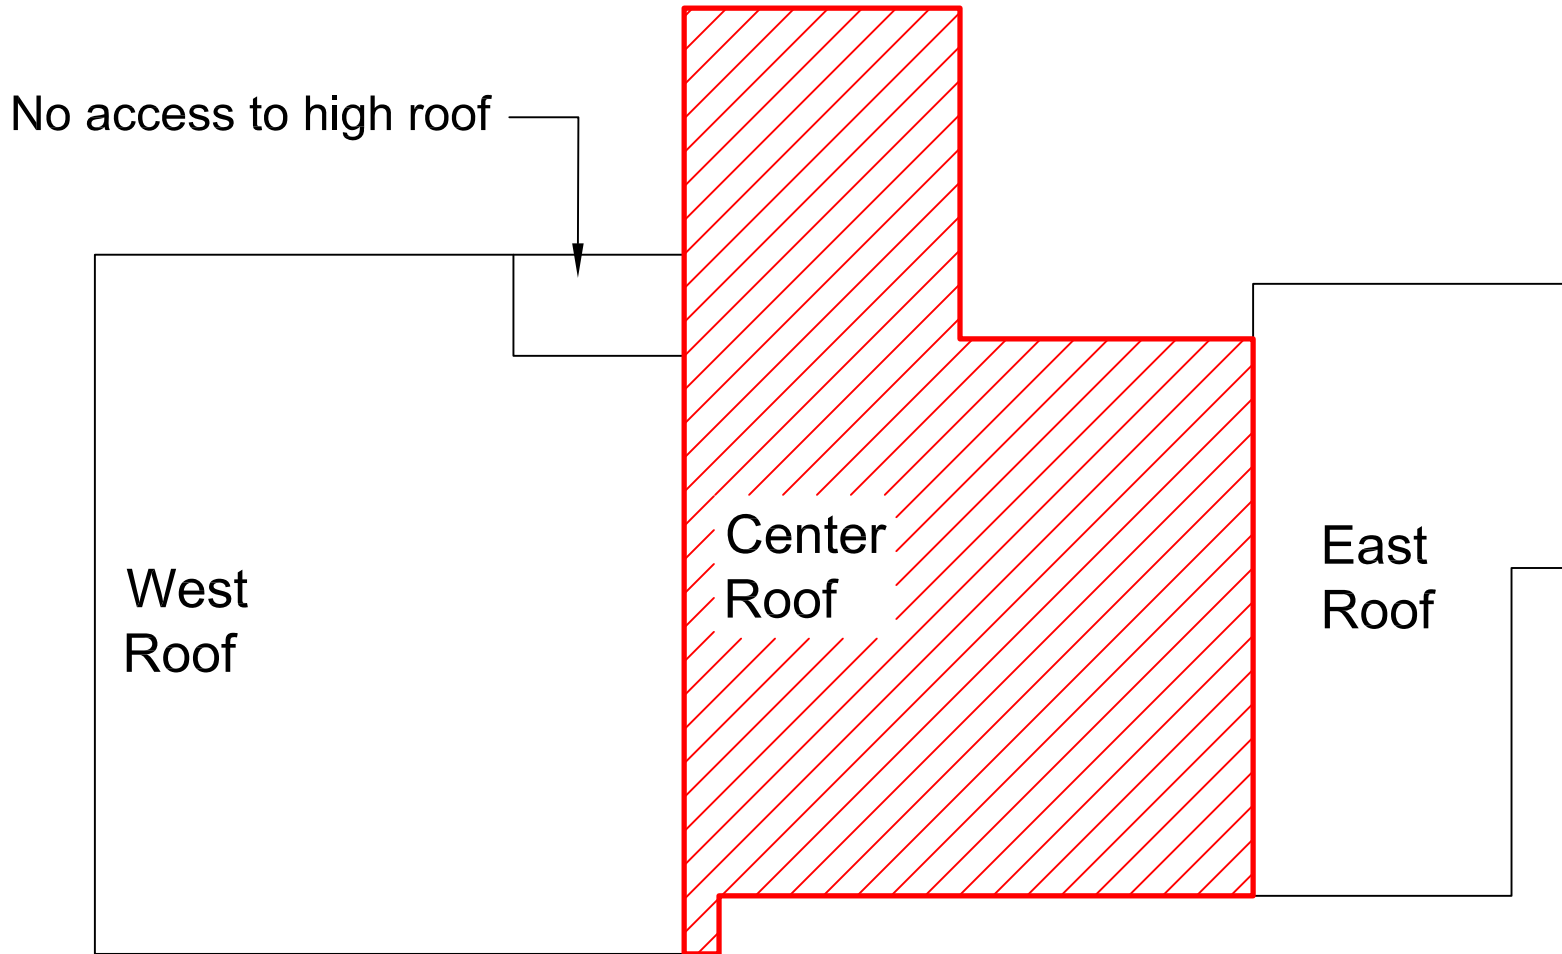
**Figure 1: Material Locations
City of Torrance - Fire Station #4
5205 Calle Mayor
Torrance, CA 90505**

Asbestos (2% chrysotile) was detected in sampled flashing mastic and pedestal mastic located on the center roof only. On the date of the inspection, the mastic was in good condition and was adhered to a metal and wood substrate. See Table 1 for a complete list of sampled materials. No asbestos was detected in other sampled materials, which included the main roofing field and parapet felts.

* Red lines and hatch notes asbestos flashing mastic and pedestal mastic located on center roof.

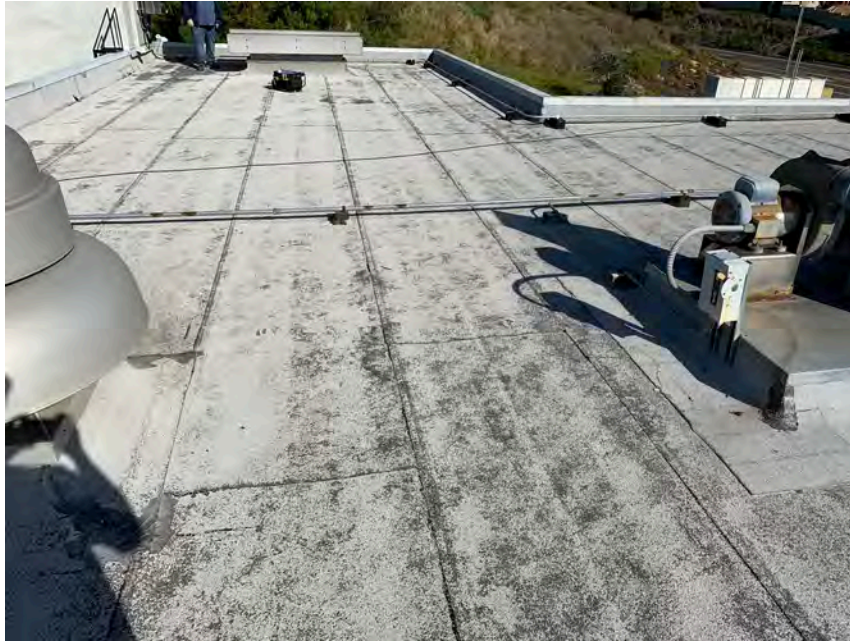
ACM flashing mastic and pedestal mastic – center roof.

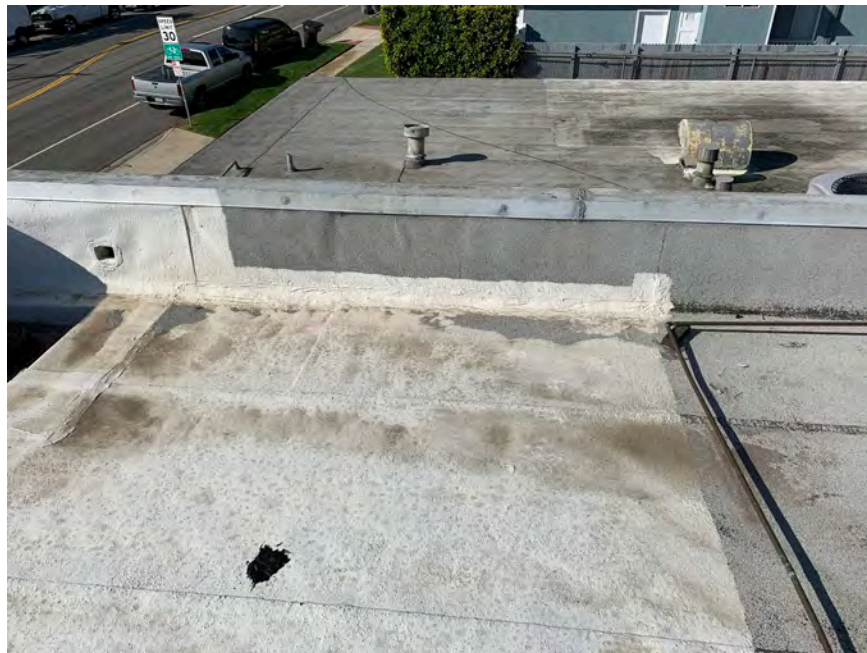
ACM flashing mastic – center roof.

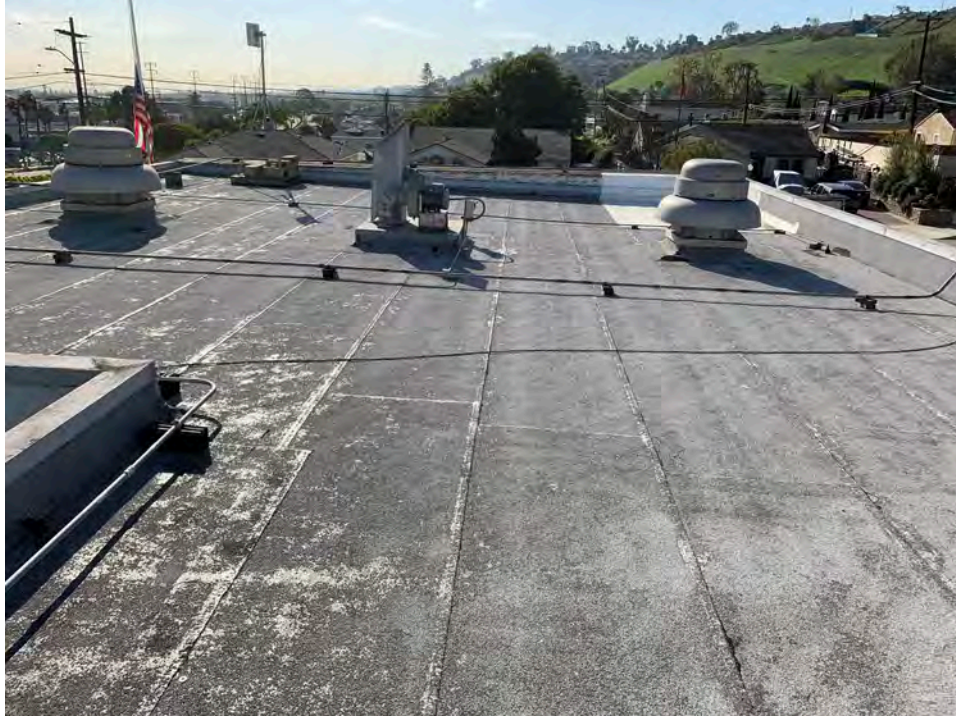
ACM pedestal mastic – center roof.

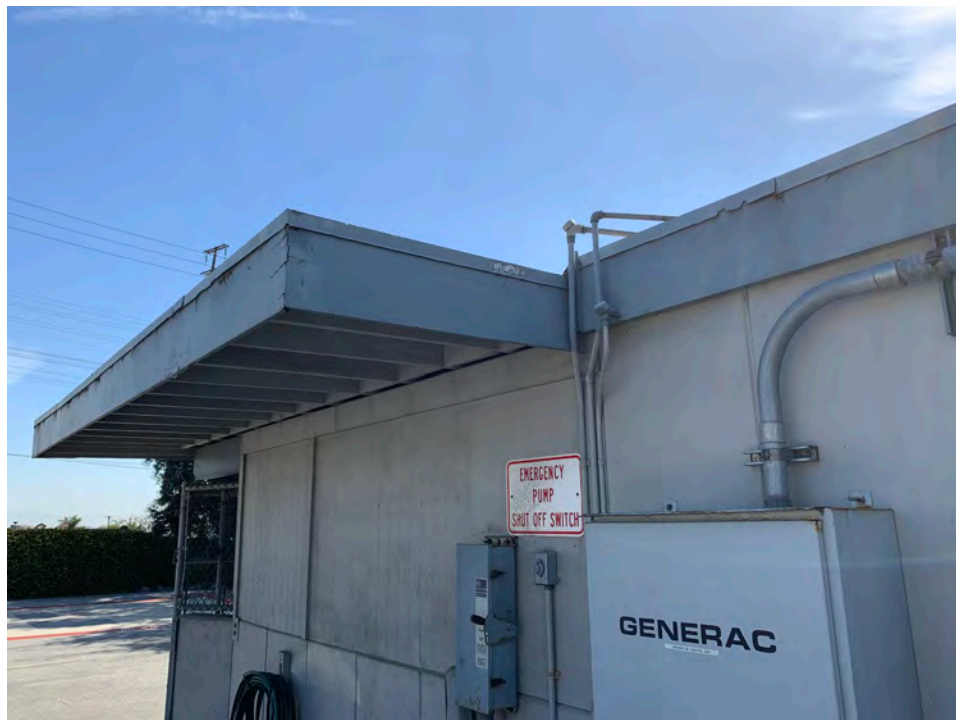
Non-lead blue flashing paint.

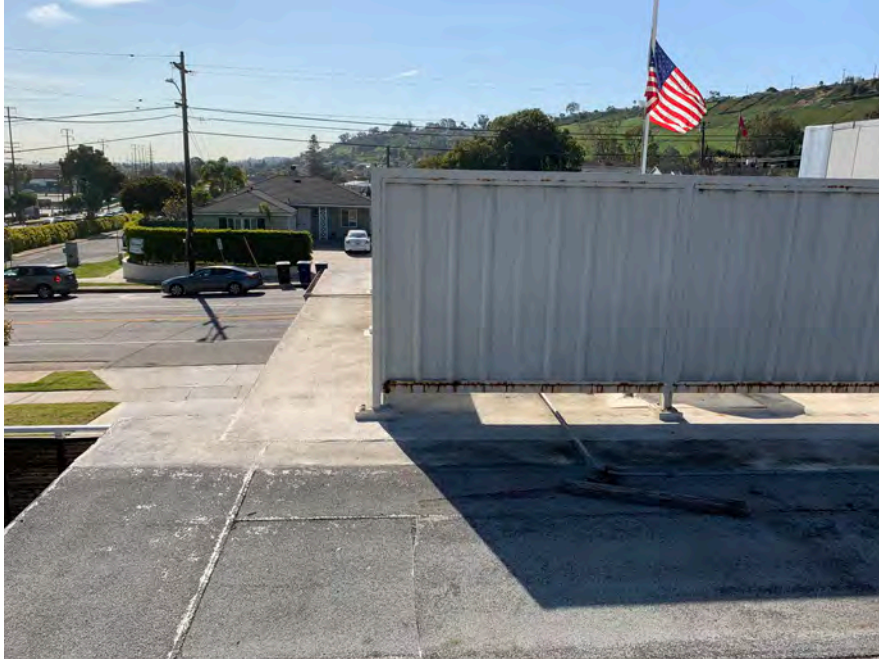
Non-lead gray gate paint.
