ADDENDUM # 2

BID NO. B2022-11

Bid for Fire Alarm Detection System at Greenwood Center

RE: ***Bulk Sampling for Asbestos and Lead – Stucco, Paint and Plaster
1520 Greenwood Ave Torrance CA***

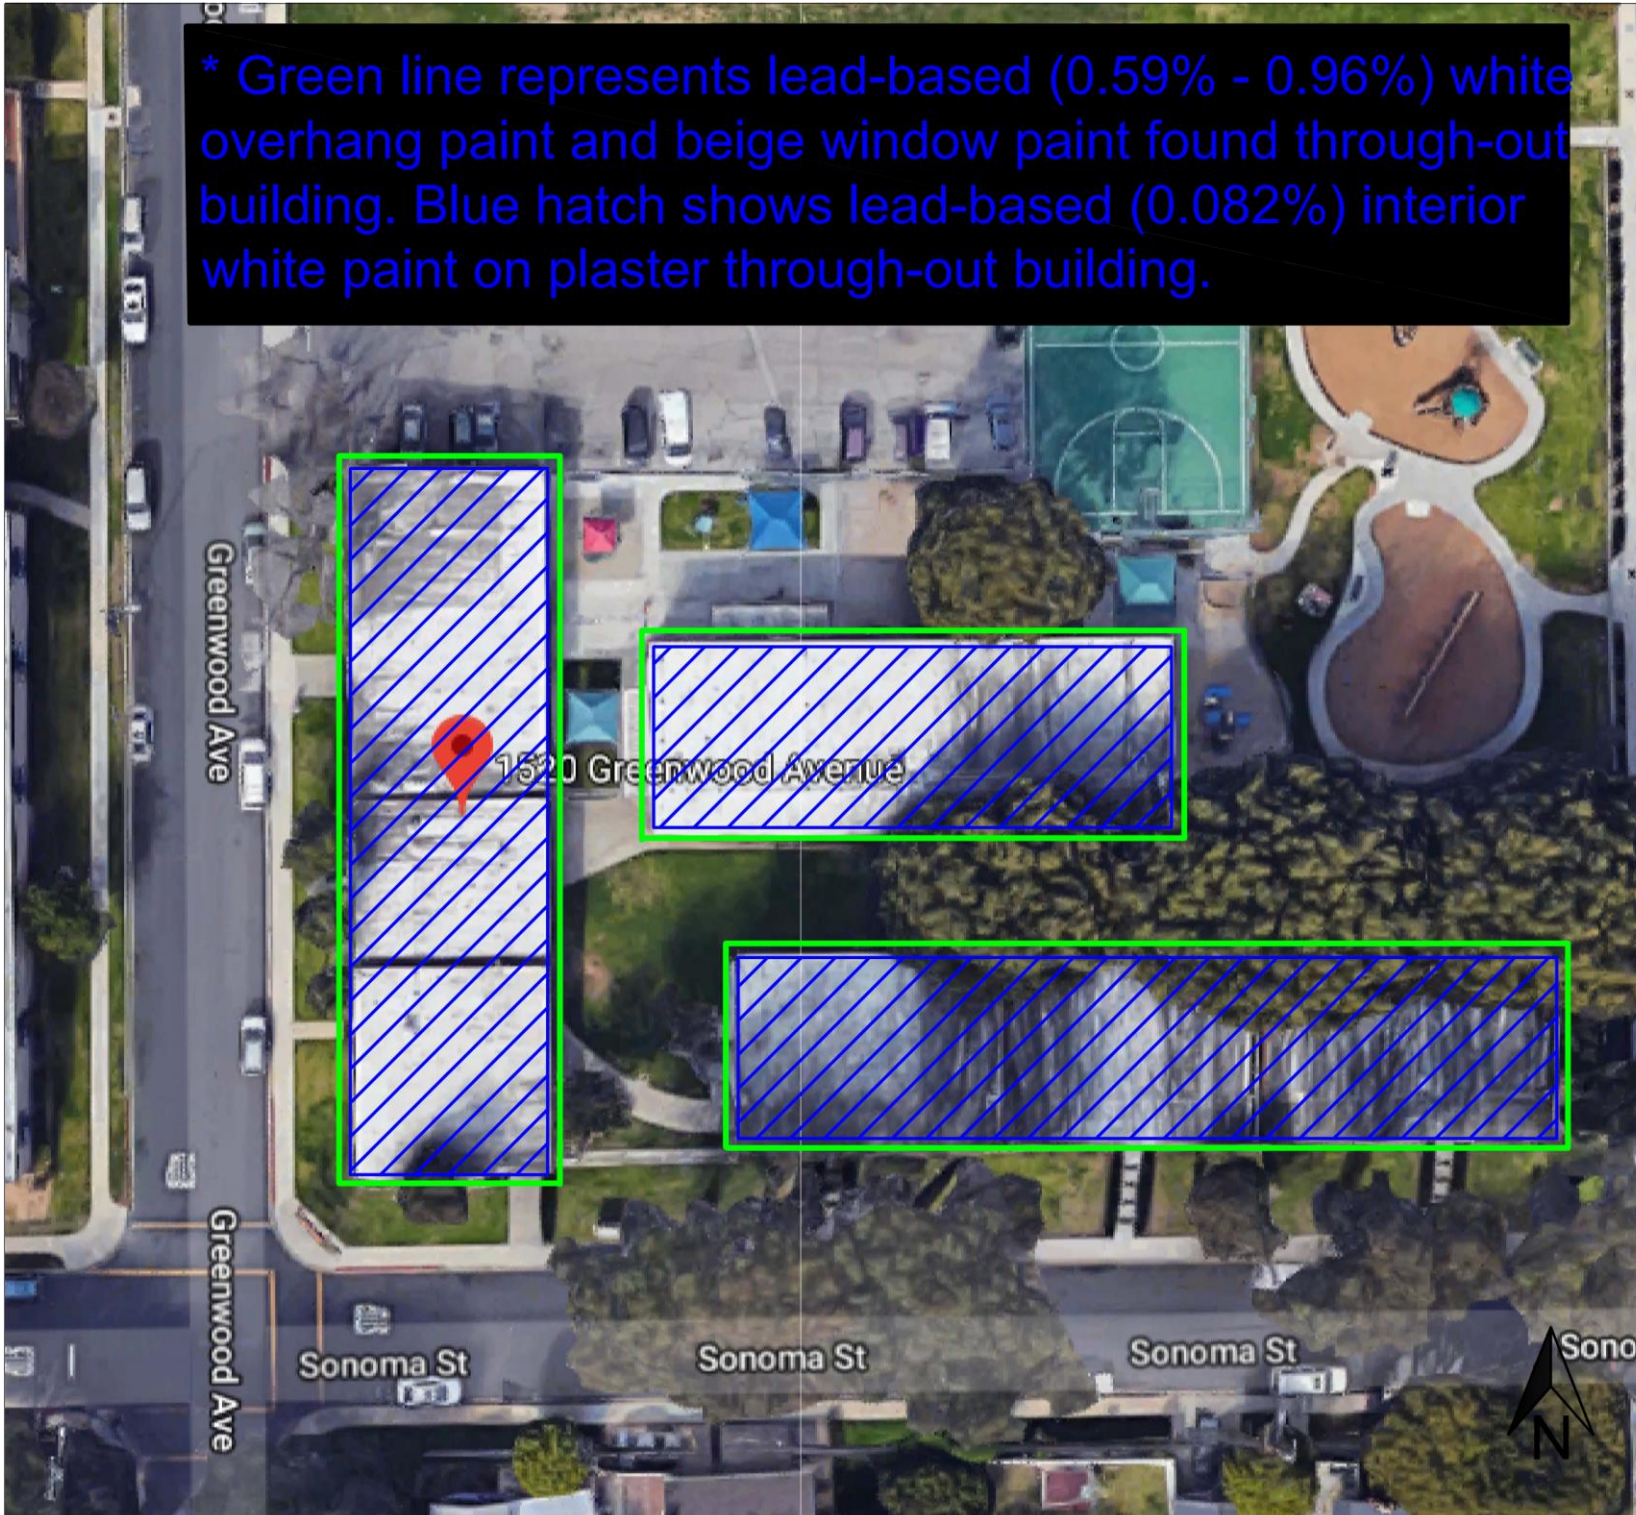
Figure 1: Material Locations
 City of Torrance- Greenwood School
 1520 Greenwood Ave.
 Torrance, CA 90503

1. No asbestos was detected at concentrations greater than 0.1 % in any of the materials sampled.¹ An abatement contractor is not required for removal; normal construction waste.
2. The following paint types are considered to be “lead-based” (>.06% lead by weight): white paint on ext. overhang, interior white paint on plaster, and beige exterior window paint. Any disturbance should be performed by a licensed abatement contractor.
3. No lead was detected in paint applied to beige stucco, interior white ceiling tiles, or white restroom wall paint.

* Green line represents lead-based (0.59% - 0.96%) white overhang paint and beige window paint found through-out building. Blue hatch shows lead-based (0.082%) interior white paint on plaster through-out building.

Mechanical grinding or torching of painted surfaces with any lead content may trigger the requirement for an “initial exposure assessment” as defined in Cal OSHA S1532.1. Please call with any questions.
