**PRELIMINARY GEOTECHNICAL
INVESTIGATION**

**PROPOSED MULTI-FAMILY
RESIDENTIAL DEVELOPMENT
HAWTHORNE BOULEVARD AND
VIA VALMONTE
TORRANCE, CALIFORNIA**

**REYLENN PROPERTIES, LLC
SOLANA BEACH, CALIFORNIA**

PROJECT NO. A9201-06-01C

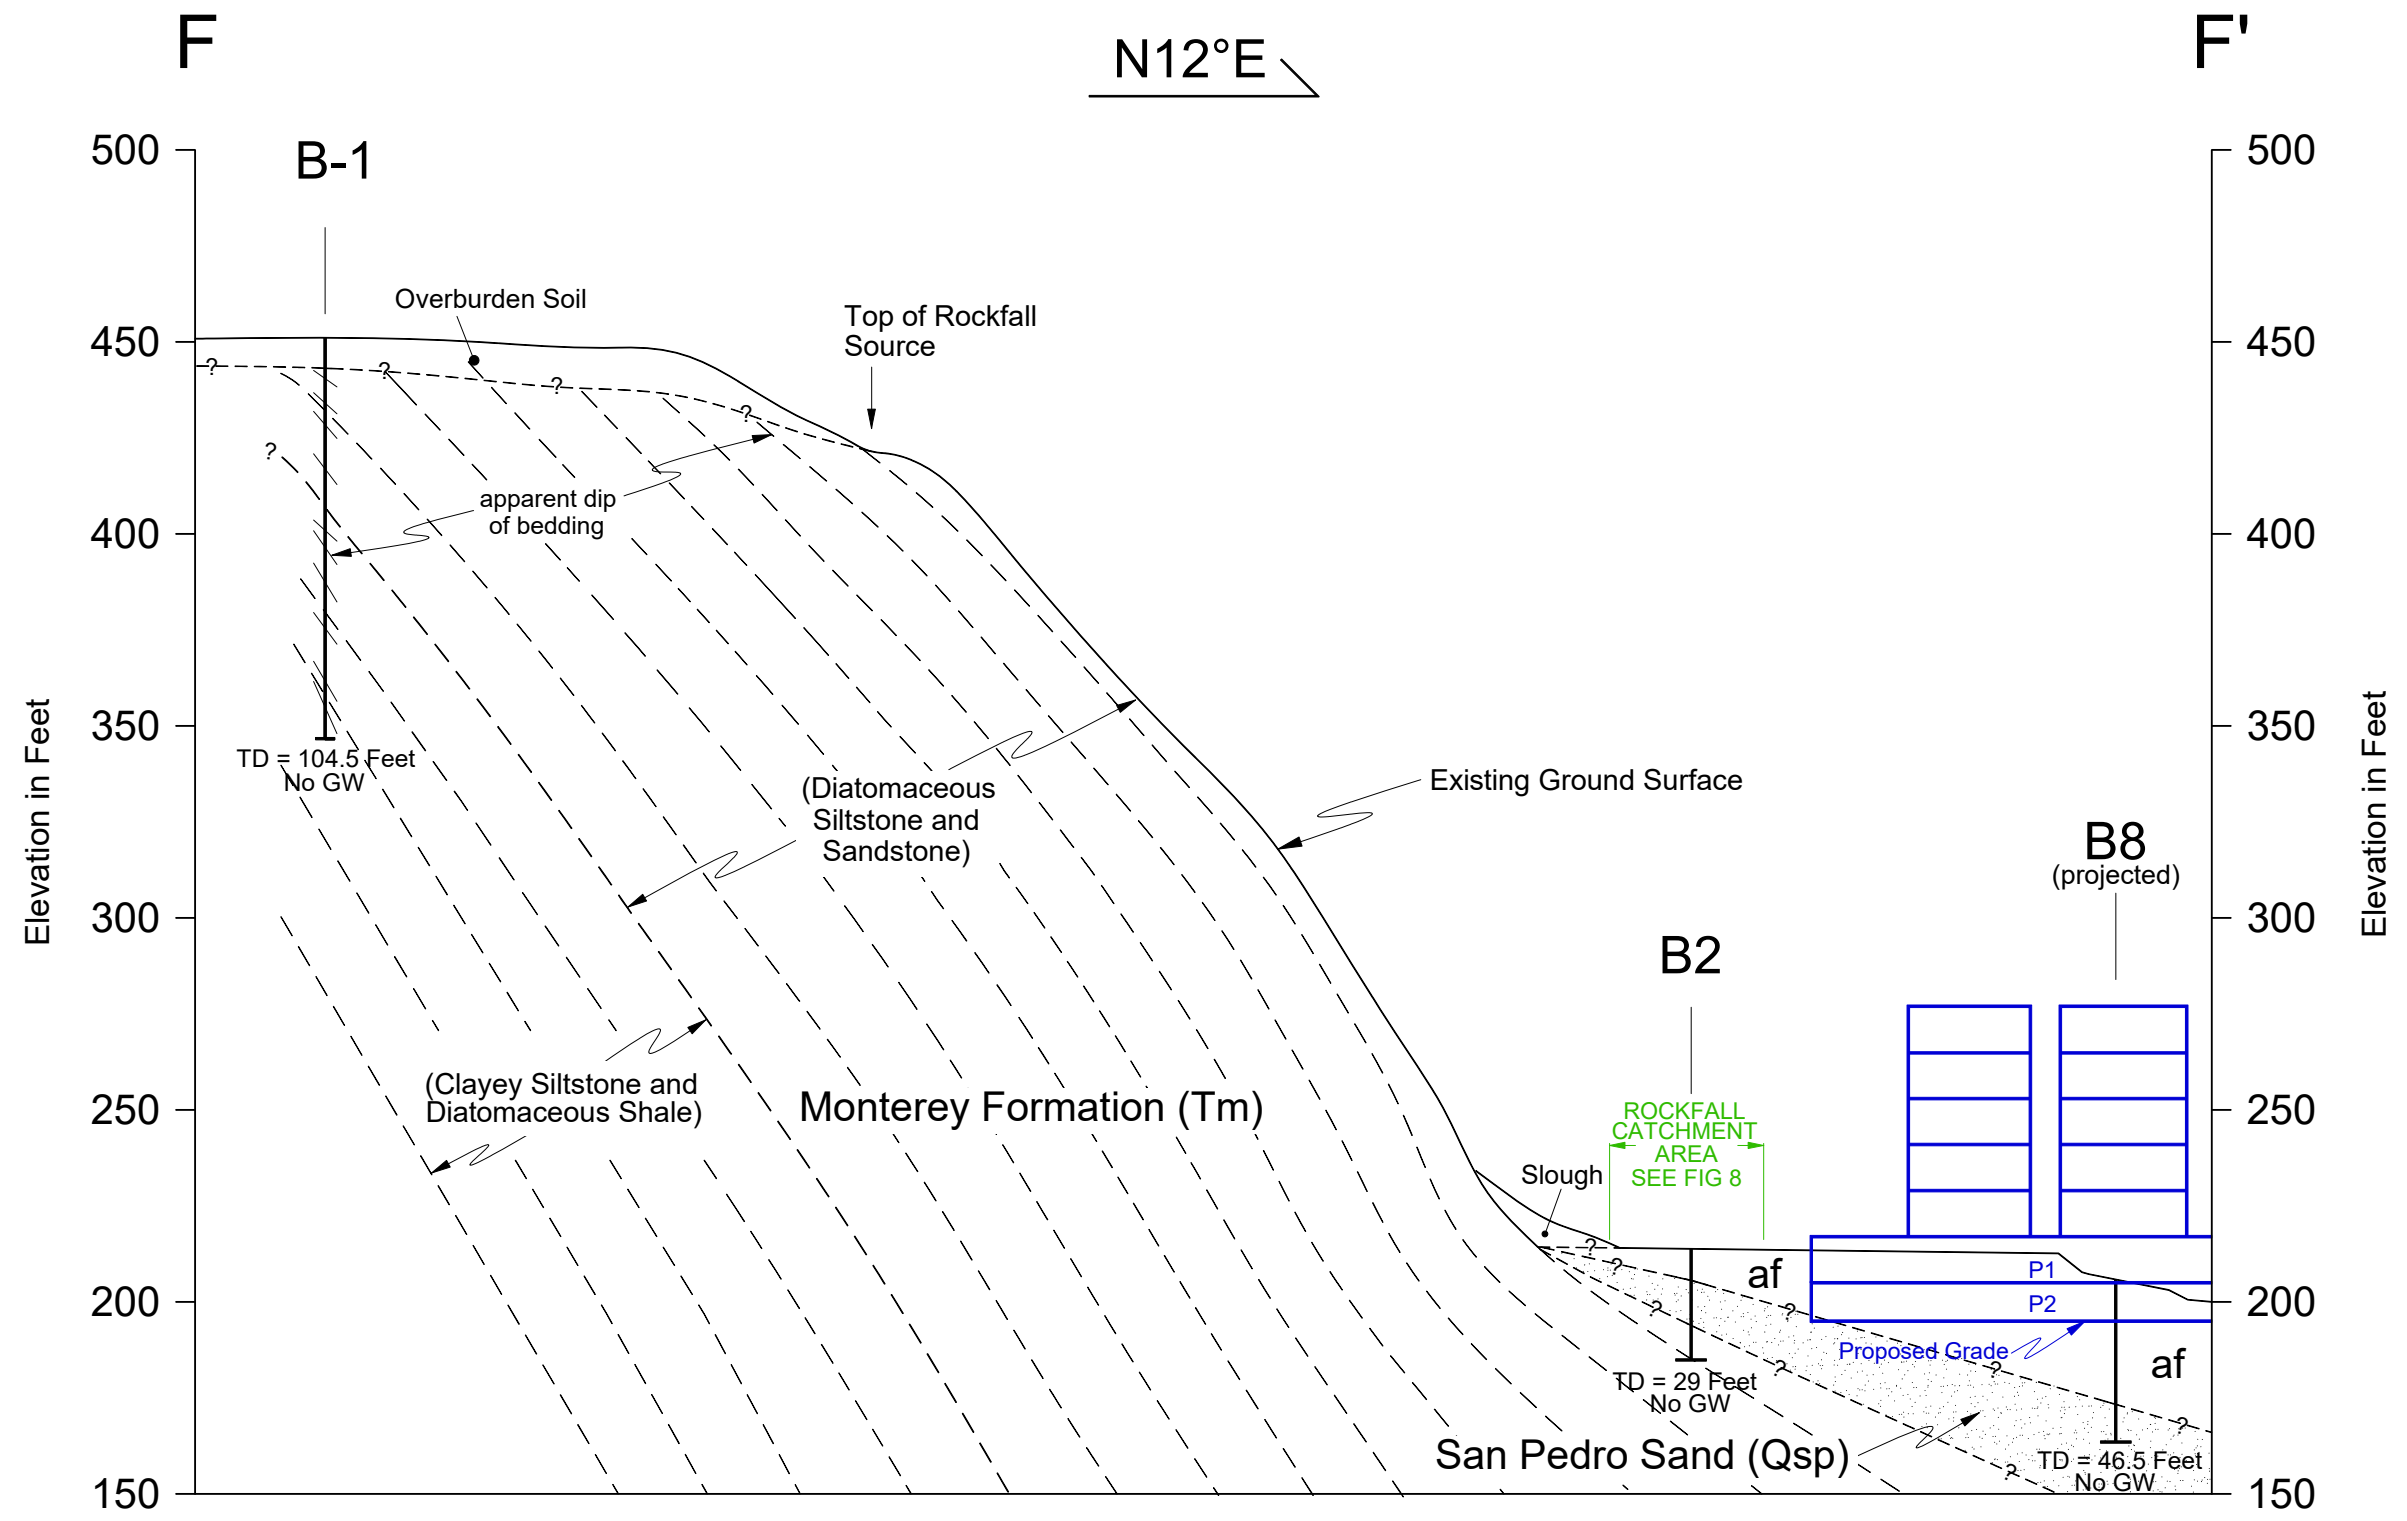
MARCH 2016 PROJECT NO. A9201-06-01C FIG. 3F

1. THE SECTIONS ARE BASED ON GEOLOGIC CONDITIONS AT BORING LOCATIONS AND AT SURFACE EXPOSURES MAPPED DURING THE INVESTIGATION. THE GEOLOGIC CONDITIONS BETWEEN SUCH LOCATIONS HAVE BEEN INTERPOLATED. LOCALIZED VARIATIONS COULD OCCUR. THE SECTIONS ARE INTENDED FOR DESCRIPTIVE PURPOSES ONLY.
2. SEE FIGURE 2 FOR LOCATION OF SECTIONS.
3. BEDDING DIPS AT SAME INCLINATION AS SLOPE

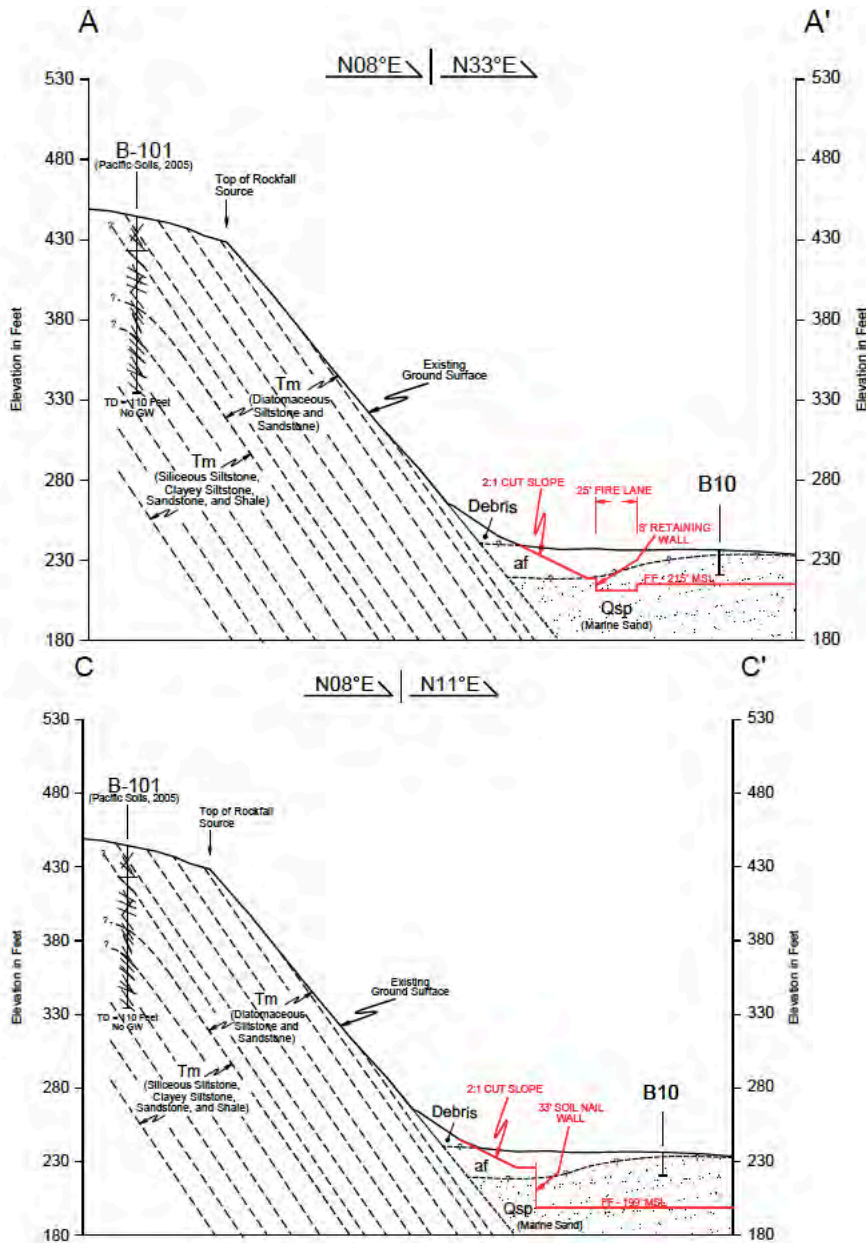
Figures 10 and 11. Cross-provided to develop the CRSP rockfall simulations.

There are two identified areas where structures are closer to the toe of the slope than for the typical areas. These two areas are identified by cross-sections named A-A' and C-C'. These two cross-sections are shown in Figures 10 and 11. The results of the analysis shows that a significant amount of horizontal roll out should be expected in the location of the proposed soil nail wall. Results are shown in Figures 12 and 13.

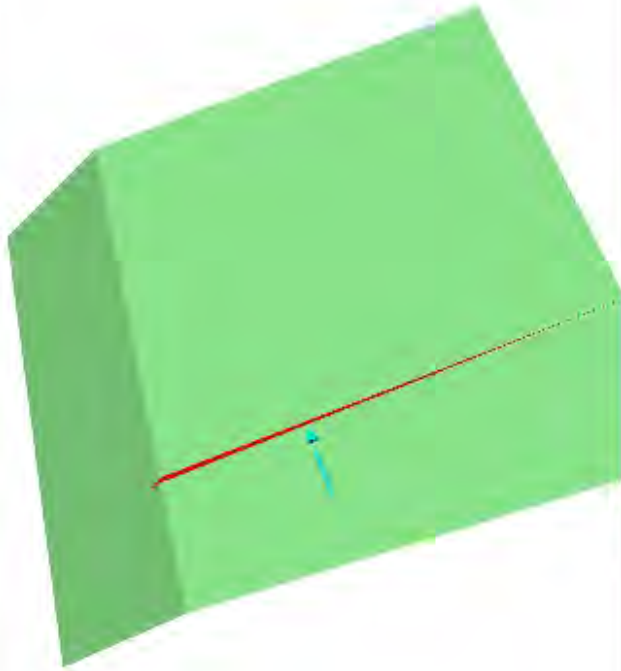
Perspective

Wedge Analysis: Pseudo-static
